Qualification Test Report

Device BC 2 Battery Cabinet
Model ZF-38A__KB
BC 2 Battery Cabinet

Report Number JID 22-01199 Rev.1
Purchase Order 10591
Job Identification JID 22-01199
Testing Date 12/08/2022
Issue Date 2/14/2023
Issued By Clark Dynamic Test Laboratory Inc.
1801 Route 51 South
Jefferson Hills, PA 15025

The purpose of this document is to present the necessary information to verify testing was performed in accordance with the referenced test standard. A satisfactory test will meet the Criteria outlined in "ACCEPTANCE CRITERIA FOR SEISMIC CERTIFICATION BY SHAKE-TABLE TESTING OF NONSTRUCTURAL COMPONENTS", ICC AC156.

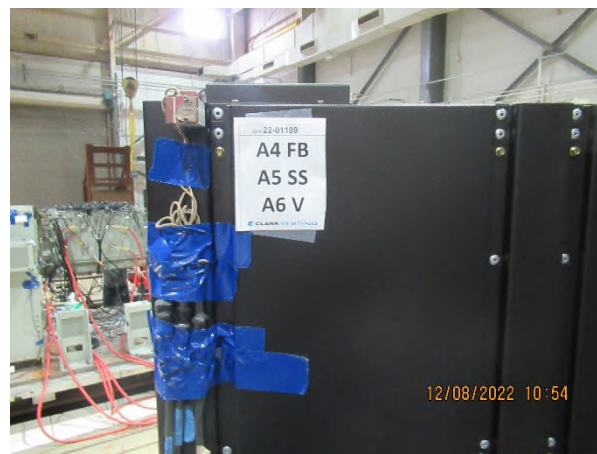
Figure 2: Placement of A4, A5, and A6

Triaxial accelerometers (A1 FB, A2 SS and A3 V) were the controls used as a constant measure of table activity. The following tables provide the characteristics and location of the instrumentation used during testing.

Name	McBee #	mV/g	Calibration Due	Location
A1 FB	4611	66.05	03/07/2023	Control – Seismic Table
A2 SS	4431	66.25	03/07/2023	
A3 V	4422	66.20	03/07/2023	
A4 FB	4616	66.40	10/27/2023	Top, Right, Side, Front
A5 SS	4174	66.27	10/27/2023	
A6 V	4176	66.95	10/27/2023

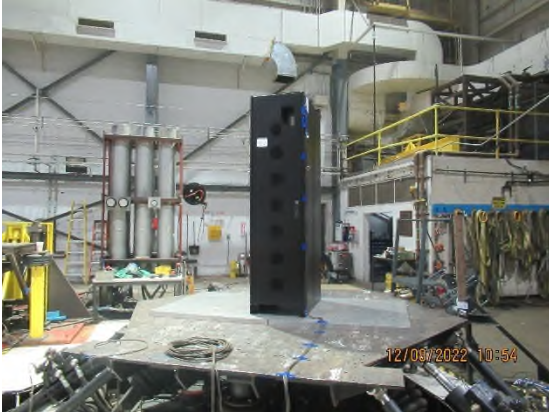
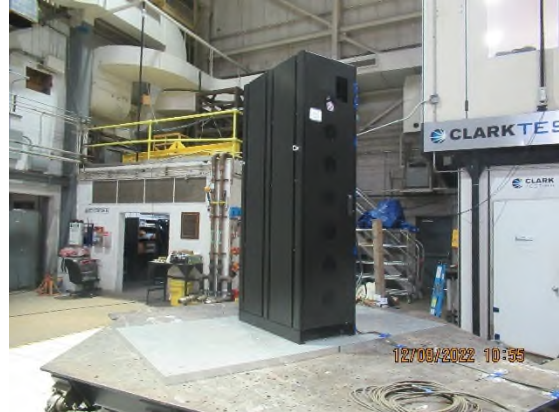
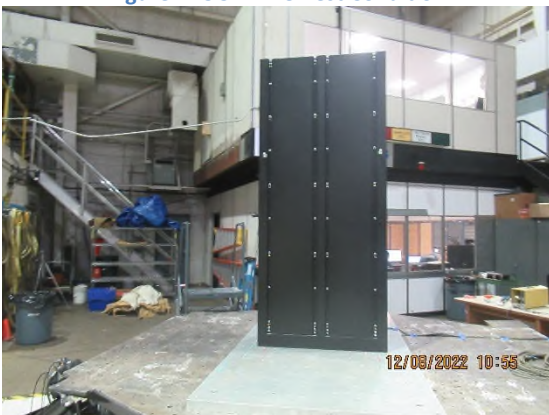
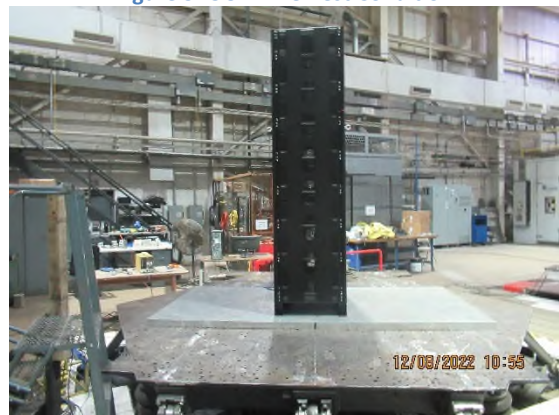
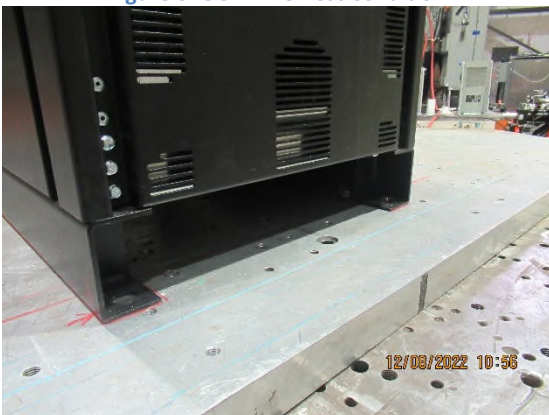
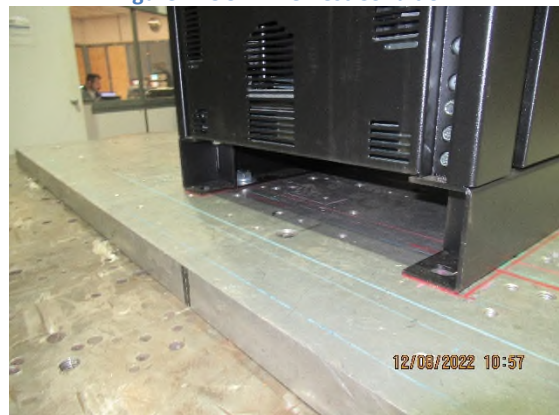
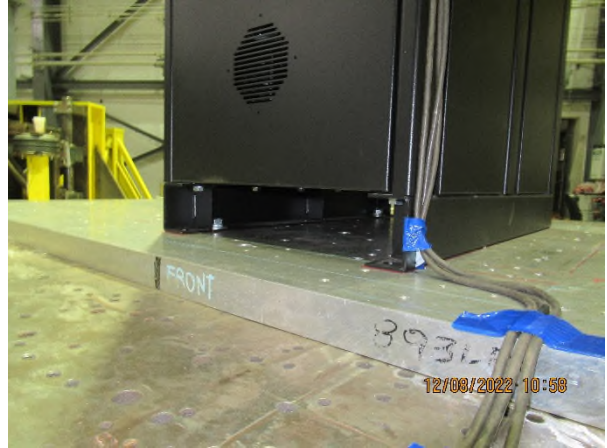
The following table describes the characteristics of the equipment. No damage was noted upon receipt inspection.

UUT1 was mounted on the seismic table using four (4) ¾"-10 SAE grade 5 hex bolts with washers, and lock washers torqued to 150ft.-lbs. The table direction to UUT1 is shown in the diagram on page I-5 of Appendix I.

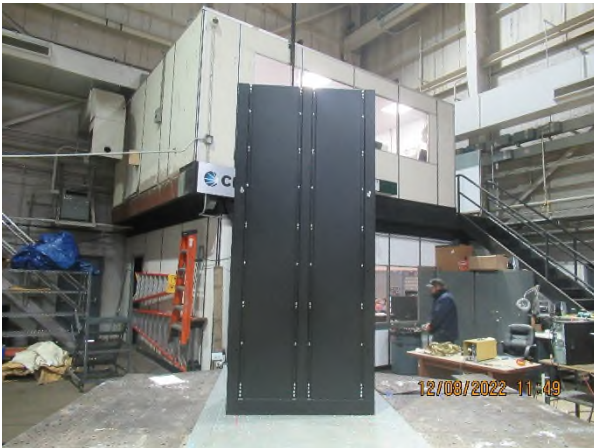
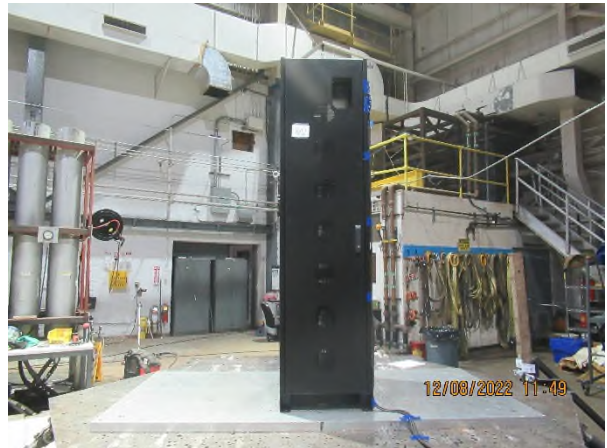
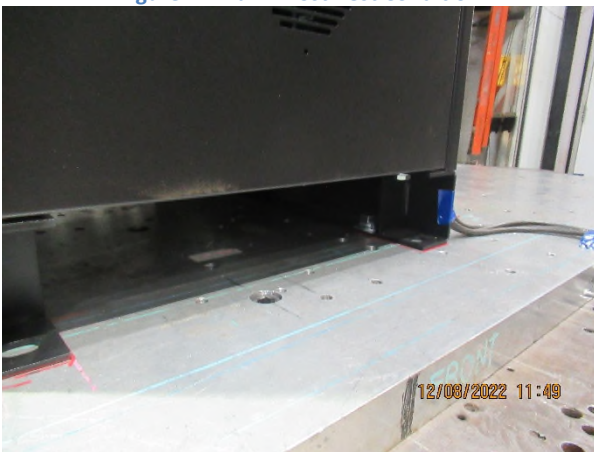
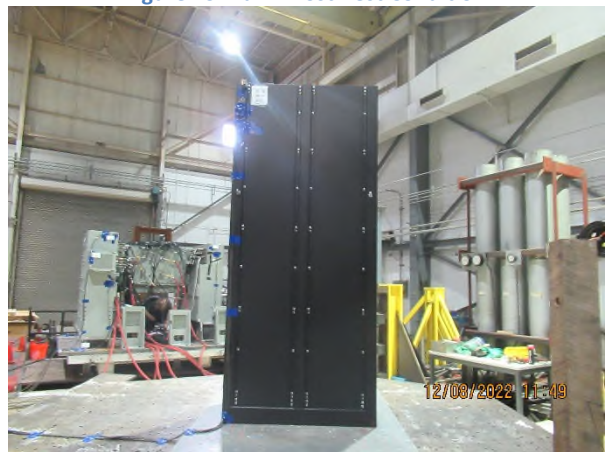
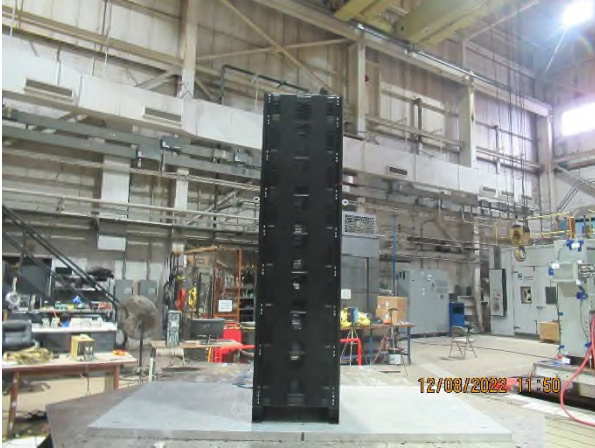
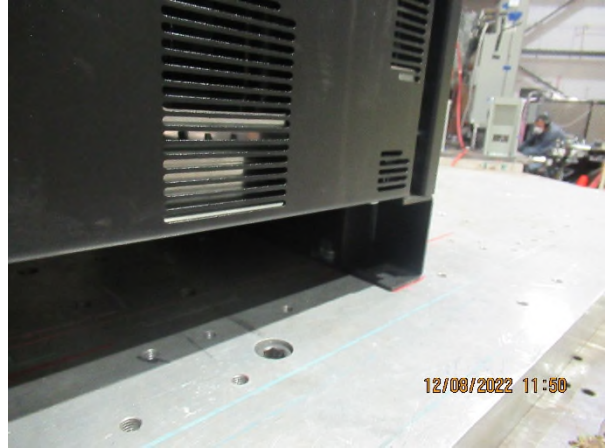
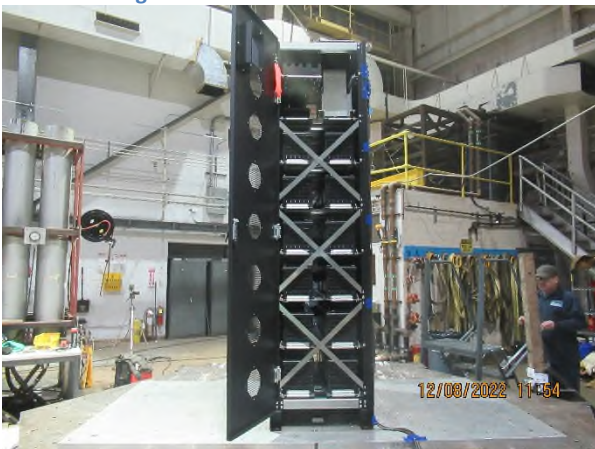
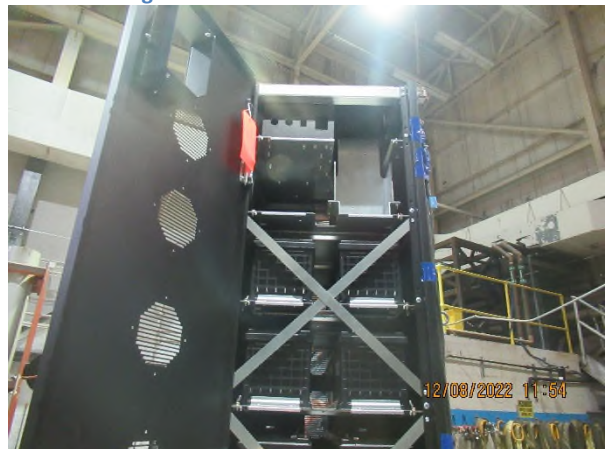
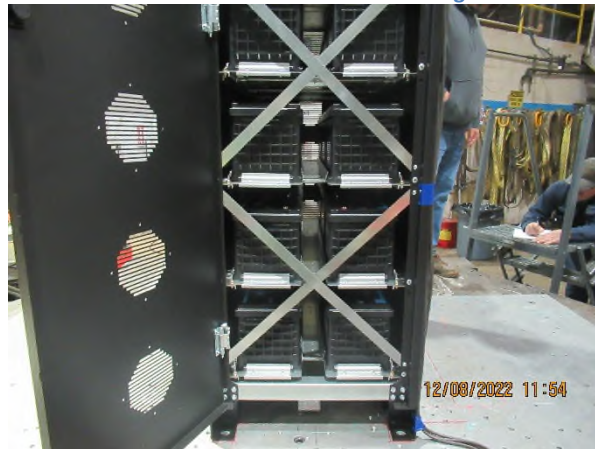
Generated table input motion and test response spectrum were reviewed against criteria detailed in ICC AC156 section 6.5. The test met the acceptance criteria and was therefore determined acceptable. Plots of the run are available in Appendix II.

Damage noted after the test:

- No damage.

The base mounting bolts were checked for torque. Proper torque value was confirmed. Aaron Schott, ZincFive representative, checked various hardware on UUT1.

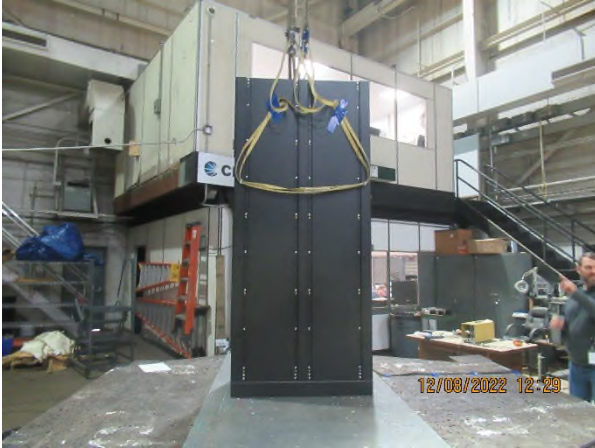
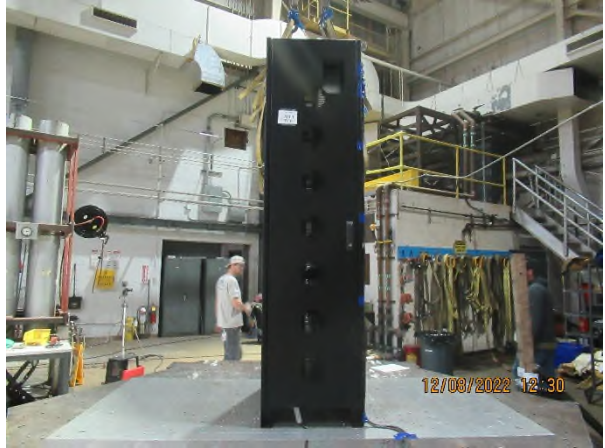
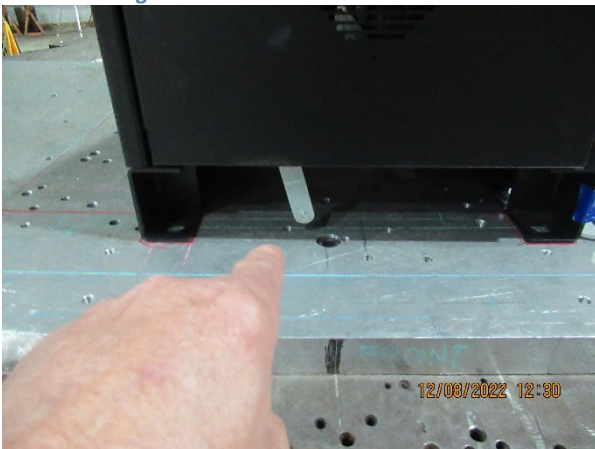
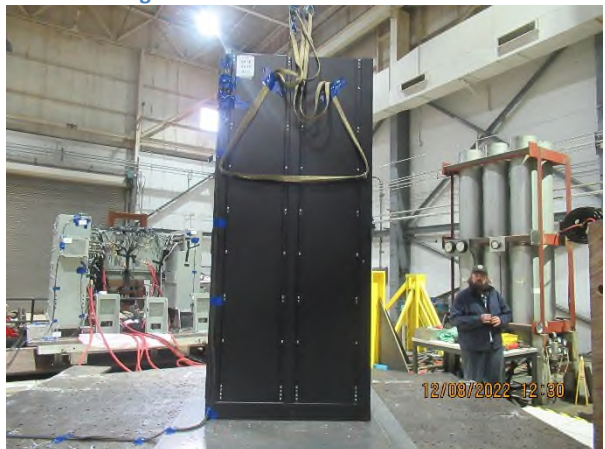
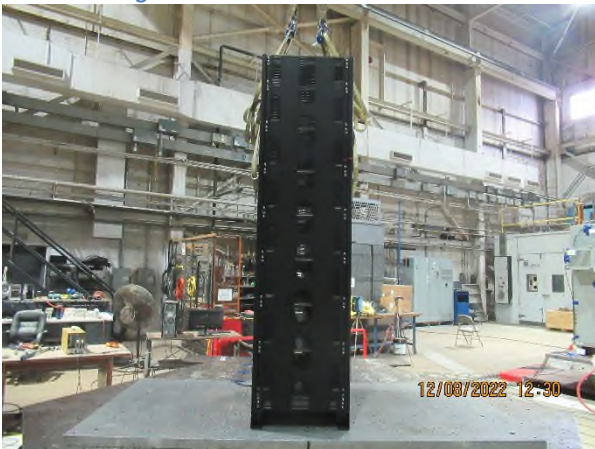
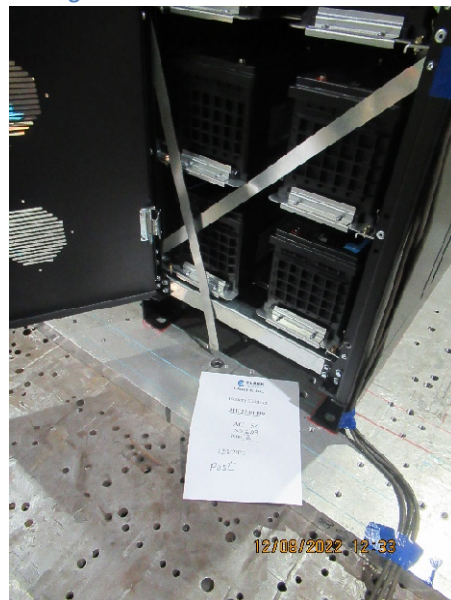
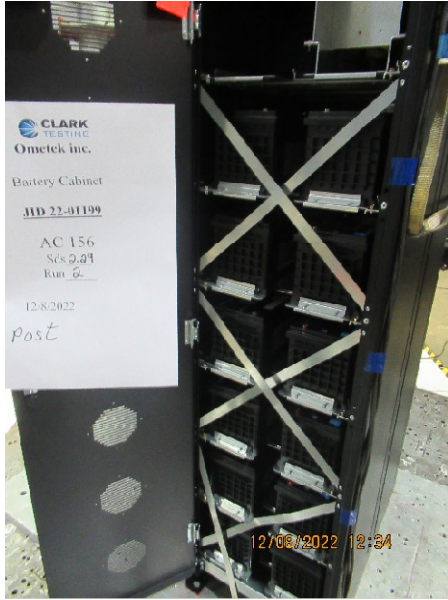
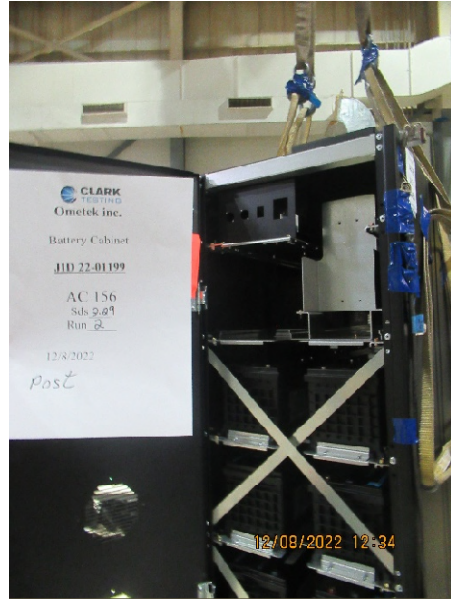
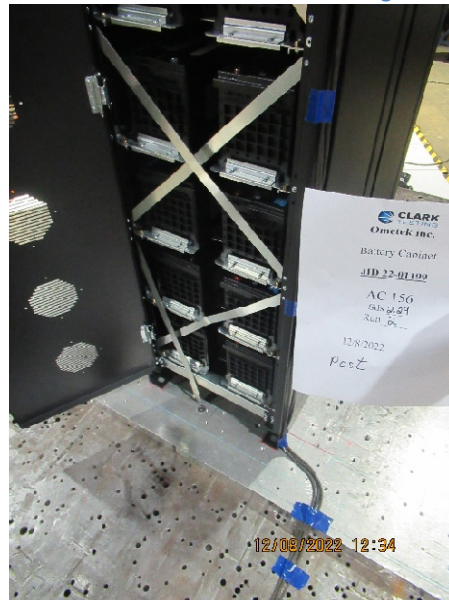
Damage noted after the test:

- The front, bottom seismic brace sheared the right cross brace mounting screw. The brace did not affect the structural ability of the cabinet, the security of the access panels/doors, and did not present any projectile hazard. Test was deemed a PASS.

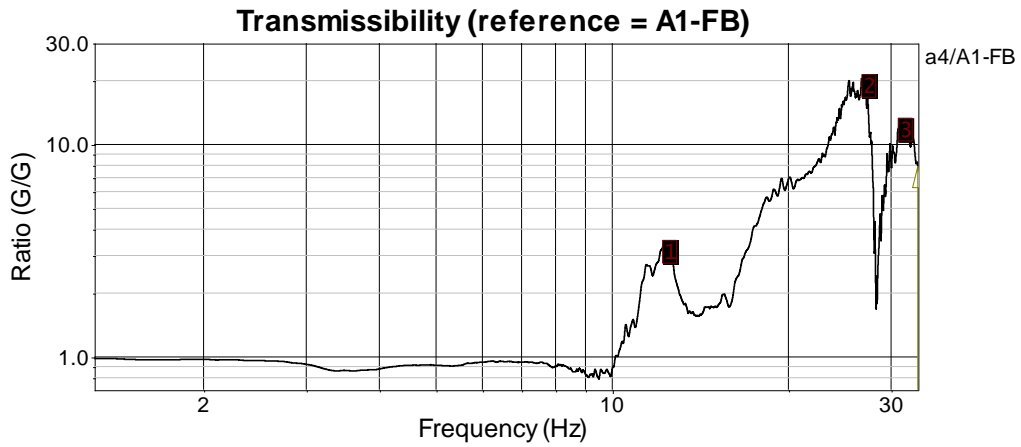
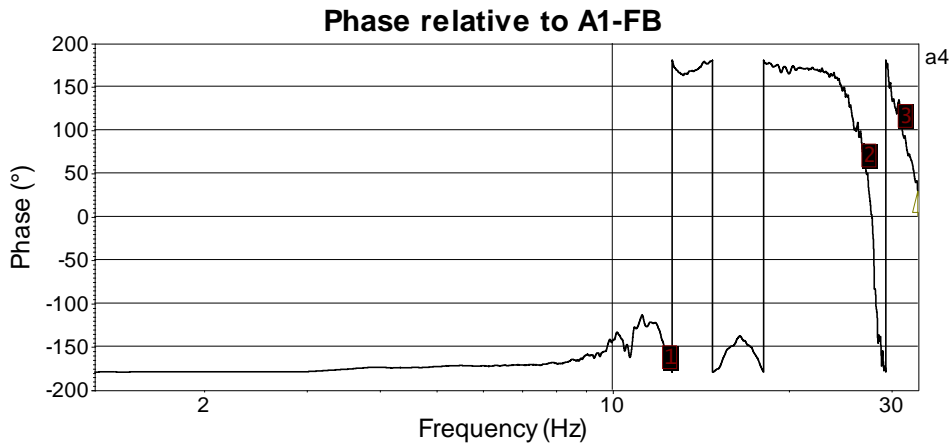
CUSTOMER	ZincFive
JID	Battery Cabinet
TIME	Dec 08, 2022 10:35:59
RUN NO.	Front to Back axis
SWEEP RATE	Sweep between 1.3 Hz and 33.3 Hz at 2 Oct/min
DURATION	0:02:21

Resonance Data			
INDEX	Frequency (Hz)	PHASE (Degree)	AMPLITUDE (G/G)
1	12.28	-151.4	3.5
2	26.89	81.4	20.9
3	31.07	126.7	13.1

UUT	RESONANCE FREQUENCY (Hz)		
Identification	Front-to-Back	Side-to-Side	Vertical
UUT 1	12.28	10.07	N/A

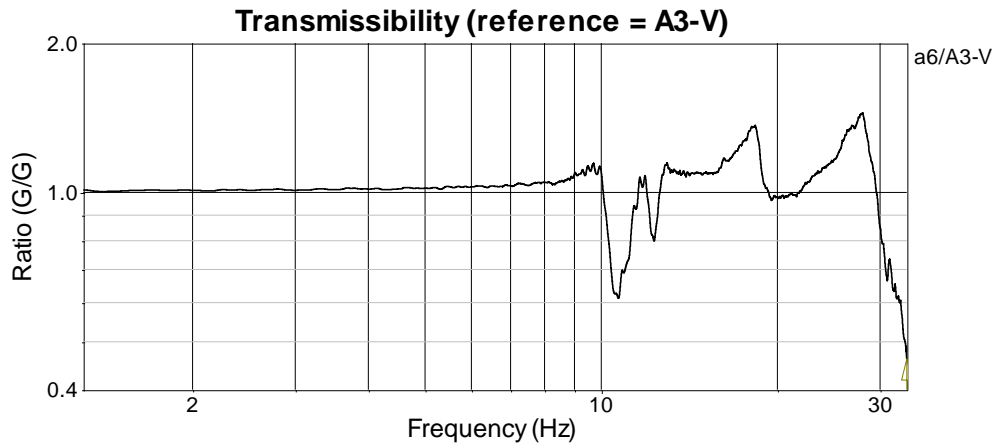
CUSTOMER	ZincFive
JID	Battery Cabinet
TIME	Dec 08, 2022 10:40:27
RUN NO.	Vertical axis
SWEEP RATE	Sweep between 1.3 Hz and 33.3 Hz at 2 Oct/min
DURATION	0:02:21

Resonance Data			
INDEX	Frequency (Hz)	PHASE (Degree)	AMPLITUDE (G/G)
1	n/a	n/a	n/a

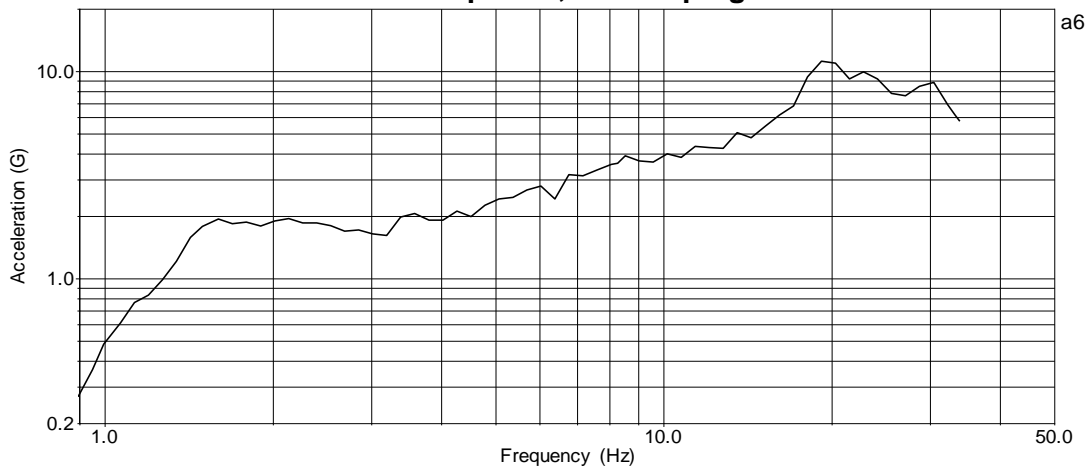
SRS Response, 5% Damping

CUSTOMER	ZincFive
JID	Battery Cabinet
TIME	Dec 08, 2022 11:27:46
RUN NO.	Run 2

Generated table input motion and test response spectrum were reviewed against criteria detailed in ICC AC156 section 6.5. The test met the acceptance criteria and was therefore determined acceptable. Plots of the run are available in Appendix II.
